PROJECT	San Jacinto River Waste Pits TCRA Post Hurricane Harvey Inspection and Maintenance			CONTRACT NO.		
CONTRACTOR	USA Environment, LP (USA) – Maintenance Hydrographic Consultants (HC) – Survey Benchmark Ecological Services (BESI) – Inspection			SUPERINTENDENT	Mike Wells (USA)	
DAY OF WEEK & DATE: Thursday, September 7, 2017			7	REPORT NO.	4	
WEATHER	Sunny; winds out of NNE			TEMPERATURE	L: 65 H: 81 F	
NUMBER/CLASS OF CONTRACTOR'S PERSONNEL:			MAJOR EQUIPMENT ON JOB (Size/capacity and hours):			
5 – USA			Skid Steer – SVL 90-2			
5 – HC			Link Belt 210 X2 Hydraulic Excavator			
3 – BESI			3 @ 12-cy dump trucks			
			on trucks			
TIDE INFORMATION:			HEALTH AND SAFETY INFORMATION:			
Time: 0800	Height:	2.00 NAVD 88	No incidents or near misses on this date.

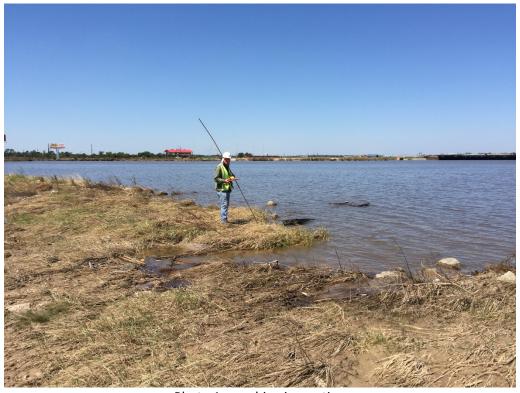
Photo 1 – probing inspection

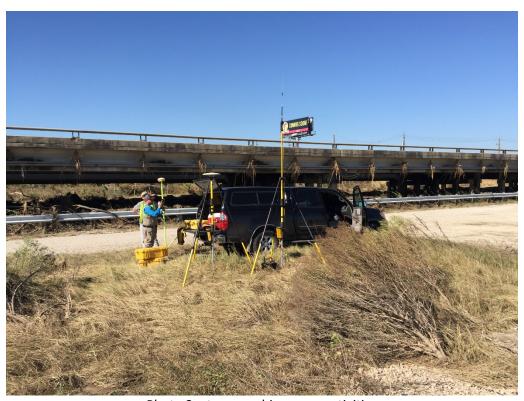
Photo 2 – topographic survey activities

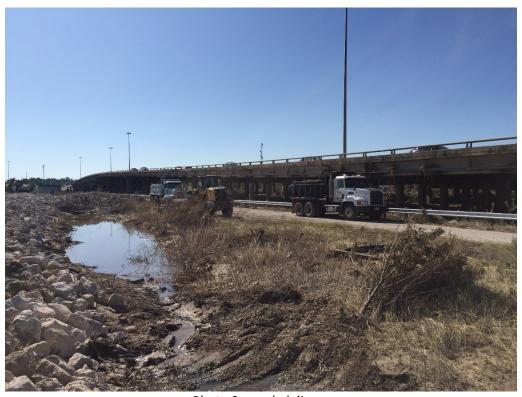
Photo 3 – rock delivery

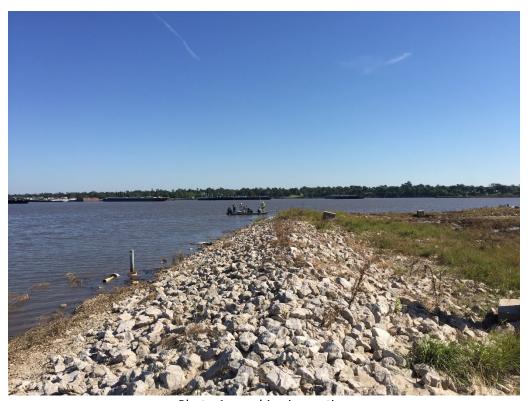
Photo 4 – probing inspection

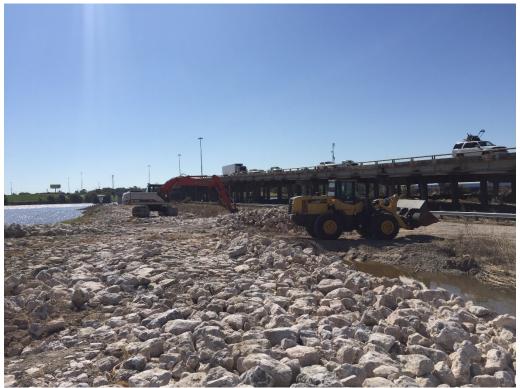
Photo 5 – southern berm crest maintenance

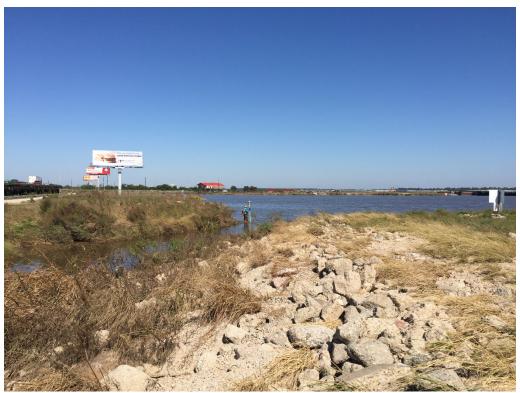
Photo 6 – hydrographic survey activities

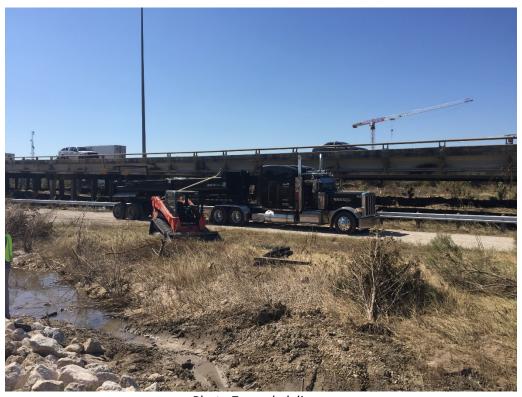
Photo 7 – rock delivery

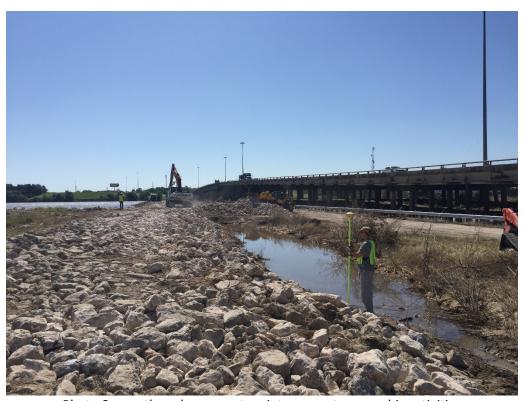
Photo 8 – southern berm crest maintenance; topographic activities

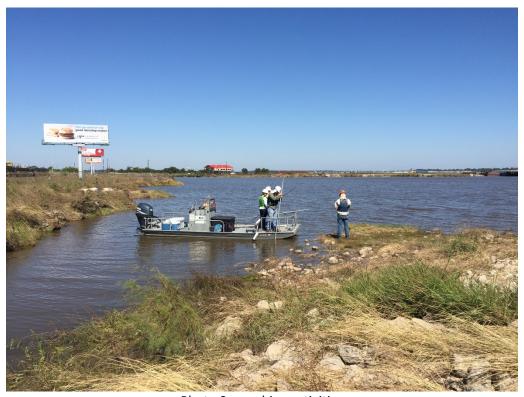
Photo 9 – probing activities
